3-YEAR ASBESTOS RE-INSPECTION REPORT

McNICHOLS EDUCATIONAL PLAZA SCRANTON, PA

**SCRANTON SCHOOL DISTRICT
425 North Washington Avenue
Scranton, Pa. 18505**

PROJECT: #SSD.19_751

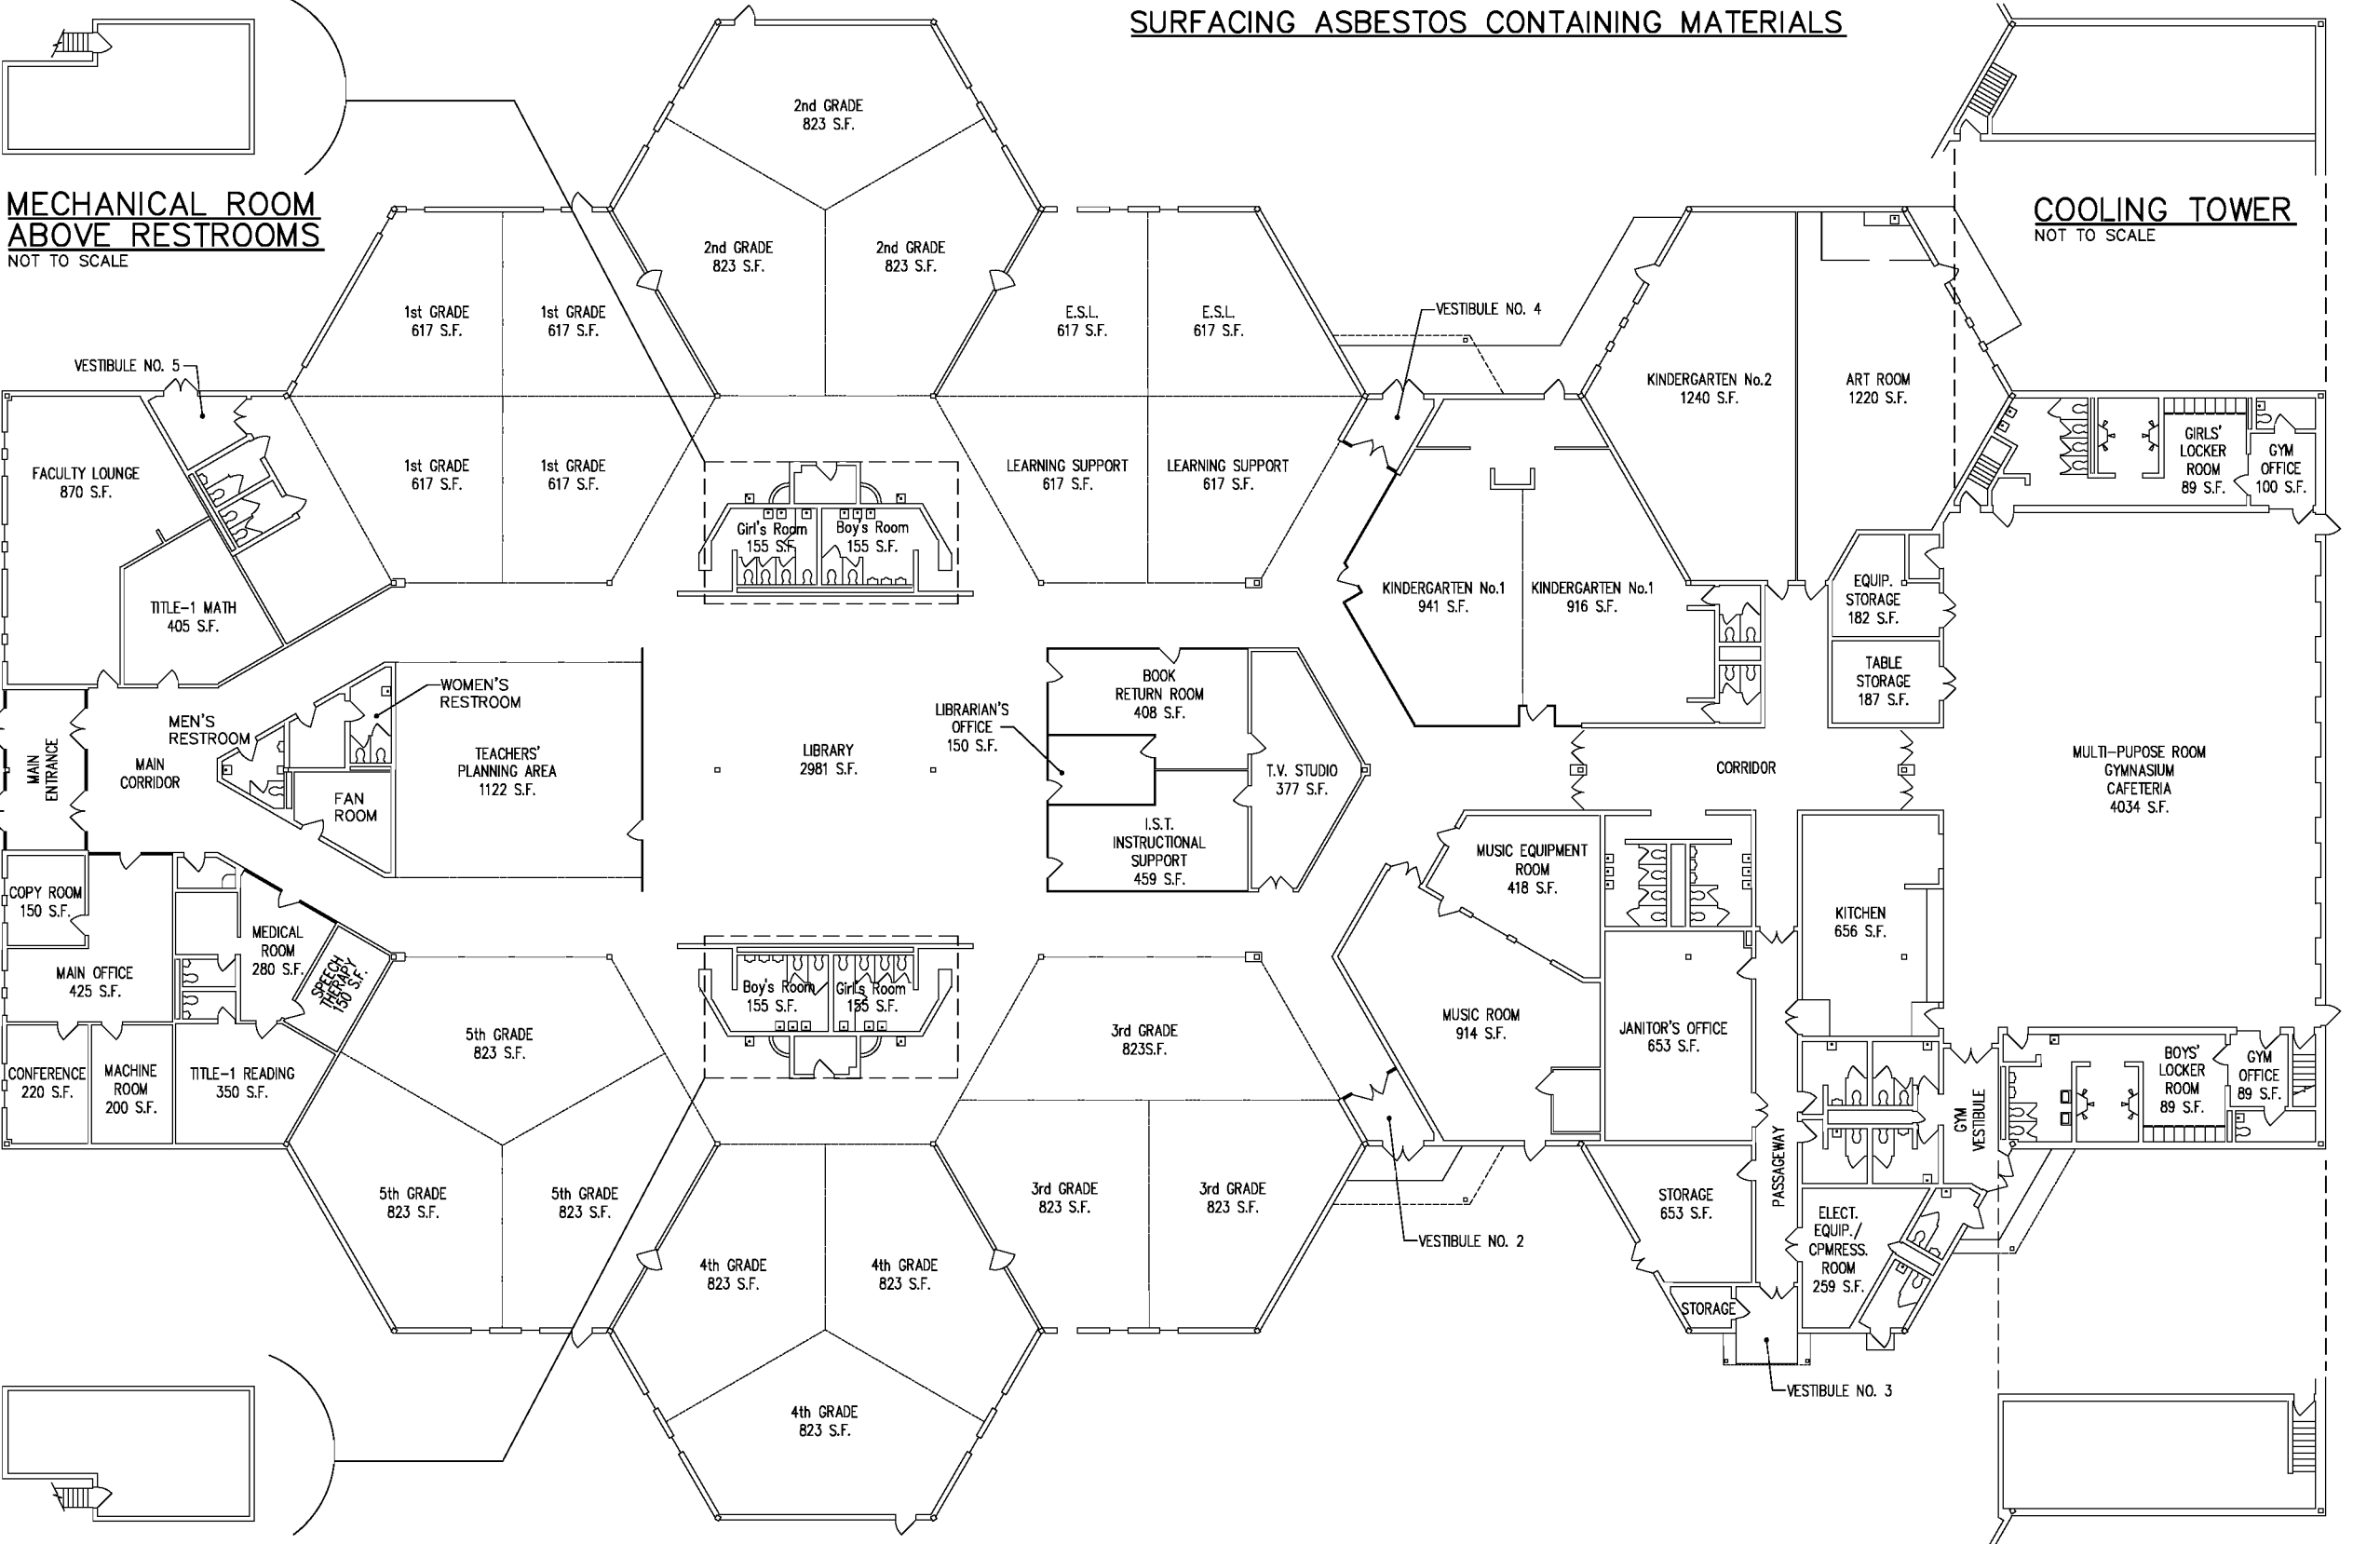
DRAWING No.: **A**
1

SURFACING ASBESTOS CONTAINING MATERIALS

KEY - SURFACING ACM
ASSUMED ASBESTOS CONTAINING
SURFACING MATERIALS:
1. EXTERIOR COATING ON SINKS
